Supplementary Information

Rapid formation of a modern bedrock canyon by a single flood event

Published in Nature Geoscience, 2010, DOI: 10.1038/NGEO894

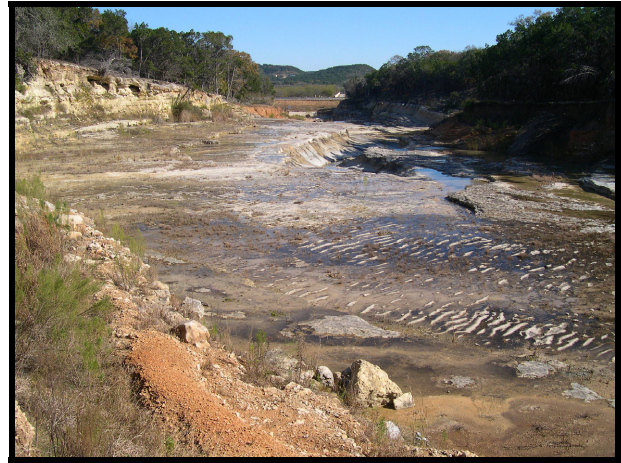
Fig. S2. Preserved Cretaceous ripple forms along a bedding plane in the upper reach of the gorge.

Several linear abrasion marks or striations are evident in the canyon (Fig. S1) and in general are oriented flow parallel (Fig. 1B, Table S1). Abrasion does not appear to have been significant in eroding the limestone bedrock in the upper part of the gorge owing to the preservation of bedding surfaces there (Fig. S2).

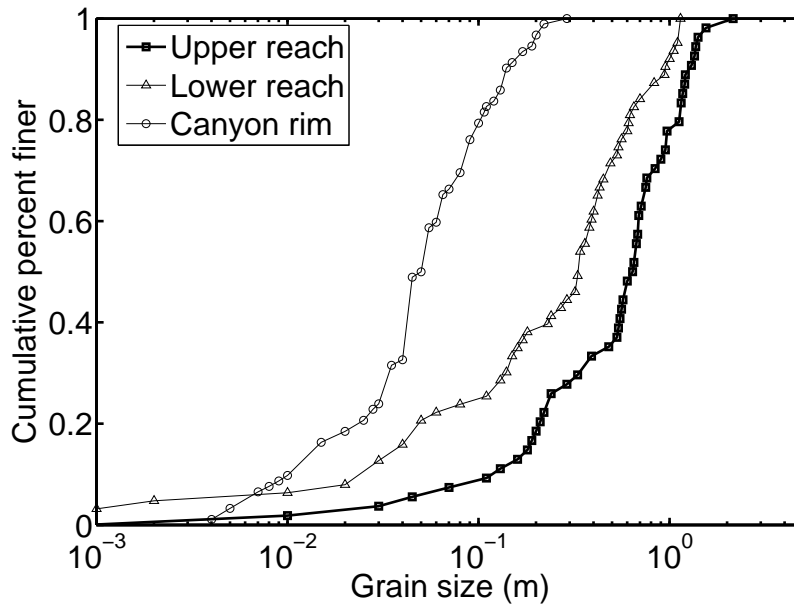
Fig. S3. Cumulative grain size distributions for the three point counts.

To estimate the median particle size for the incipient motion calculations, we made point count of sediment within a boulder bar at $0.15 \text{ km} < x < 0.25 \text{ km}$. The intermediate diameters of 100 particles were measured where they intersected a 1 m x 1 m grid^{S3}. The distributions are given in Fig. S3 and the median particle sizes was 0.65 m. A similar method was used to estimate the median diameter of particles deposited along the canyon rim, but this time a grid spacing of $\sim 0.2 \text{ m}$ was used, yielding a median size of 0.05 m (Fig. S3, Table S2).
